Subject IFRC – Transitional Shelter

Job No/Ref 214933/ER

Date 26<sup>th</sup> April 2011

# Shelter 1: Structural Assessment – Indonesia, Padang

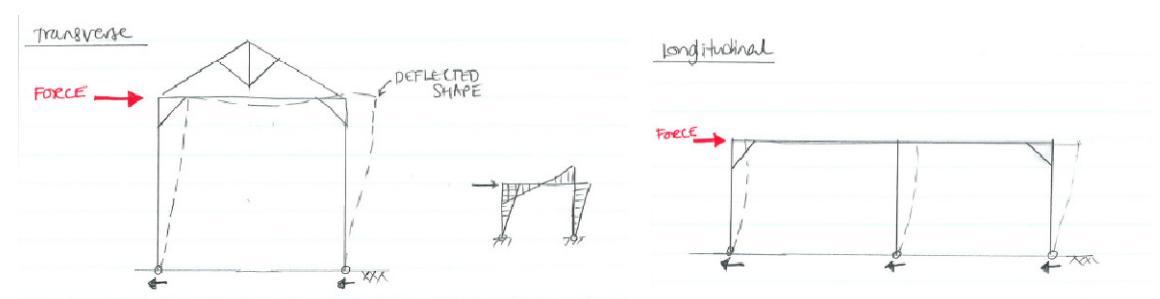
Figure 1.3 – Deflected Shape of Lateral System

- Vertical loads are taken by 8 columns supported on concrete bucket foundations.
- Global stability in the transverse direction is provided by three portal (moment) frames. These consist of two or three columns and a roof truss with bracing members at the haunches.
- Global stability in the longitudinal direction is provided by two moment frames at each side, with stiffened haunches.

- There are single or double diagonal bracing members between portal frames in the longitudinal direction but these do not contribute to the structural system since there are no tie members between portal frames at eaves level.
- There is no bracing in the plane of the roof; therefore it cannot act as a diaphragm when palm thatch is used. Bracing or properly nailed roof sheets will be required to achieve diaphragm action.
- There is no code compliant lateral stability system in the shelter and the stability is dependent on the haunches of the portal frames.

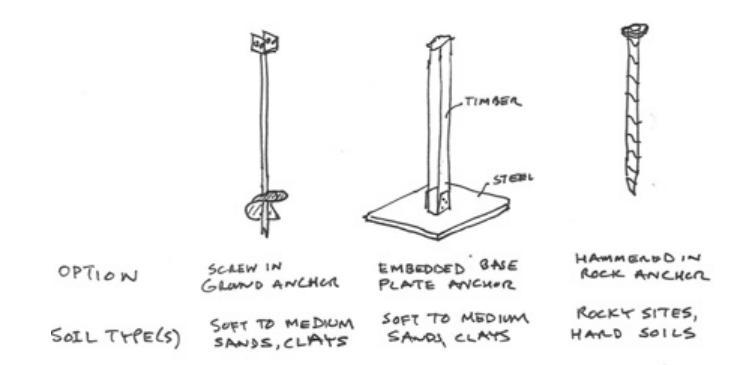
**Figure 2.1 – Alternative Foundation Options**

- The shelter can be upgraded to case B by the use of corrugated iron or zinc sheeting fixed to the roof purlins or joists. In this case the roof will attract wind loads, but the walls are still considered skeletal.
- The wind loads result in foundation uplift for both Case B and C. In other words, the total dead load of the structure including the weight of the footing is much less than the vertical uplift demand caused by the wind case. However, it been assumed that the columns are simply cast into concrete footings without any continuous connection detail. It is therefore likely that the columns will pull out and not engage the foundations in the uplift condition, worsening the magnitude of net uplift on the foundations. A possible alternative foundation solution to prevent uplift would be the use of ground anchors as shown in Figure 2.1.

- The foundations would need to be more substantial in order to prevent sliding under wind lateral loads, and to prevent uplift which is greater than for Case B. The lateral connection of the columns to the foundations requires at least 100mm of embedment of the column into the concrete. In both cases the bearing pressures are acceptable.

- C. CHANGE: Columns should be properly tied to foundations to prevent uplift of the structure. Use Type 4 or 5 foundations (see C.1) to resist uplift under seismic loads and wind loads if upgraded.
