## B.13 Sri Lanka - 2004 - Tsunami

### Overview of the tsunami response

## B.14 Sri Lanka - 2004 - Tsunami

### Case study: Transitional shelter construction

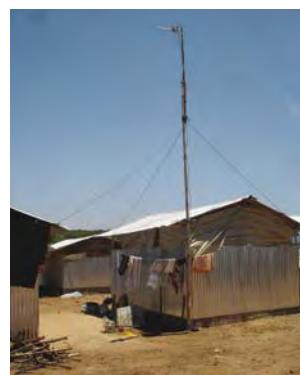
*One of many transitional shelter designs adapted by its occupants*

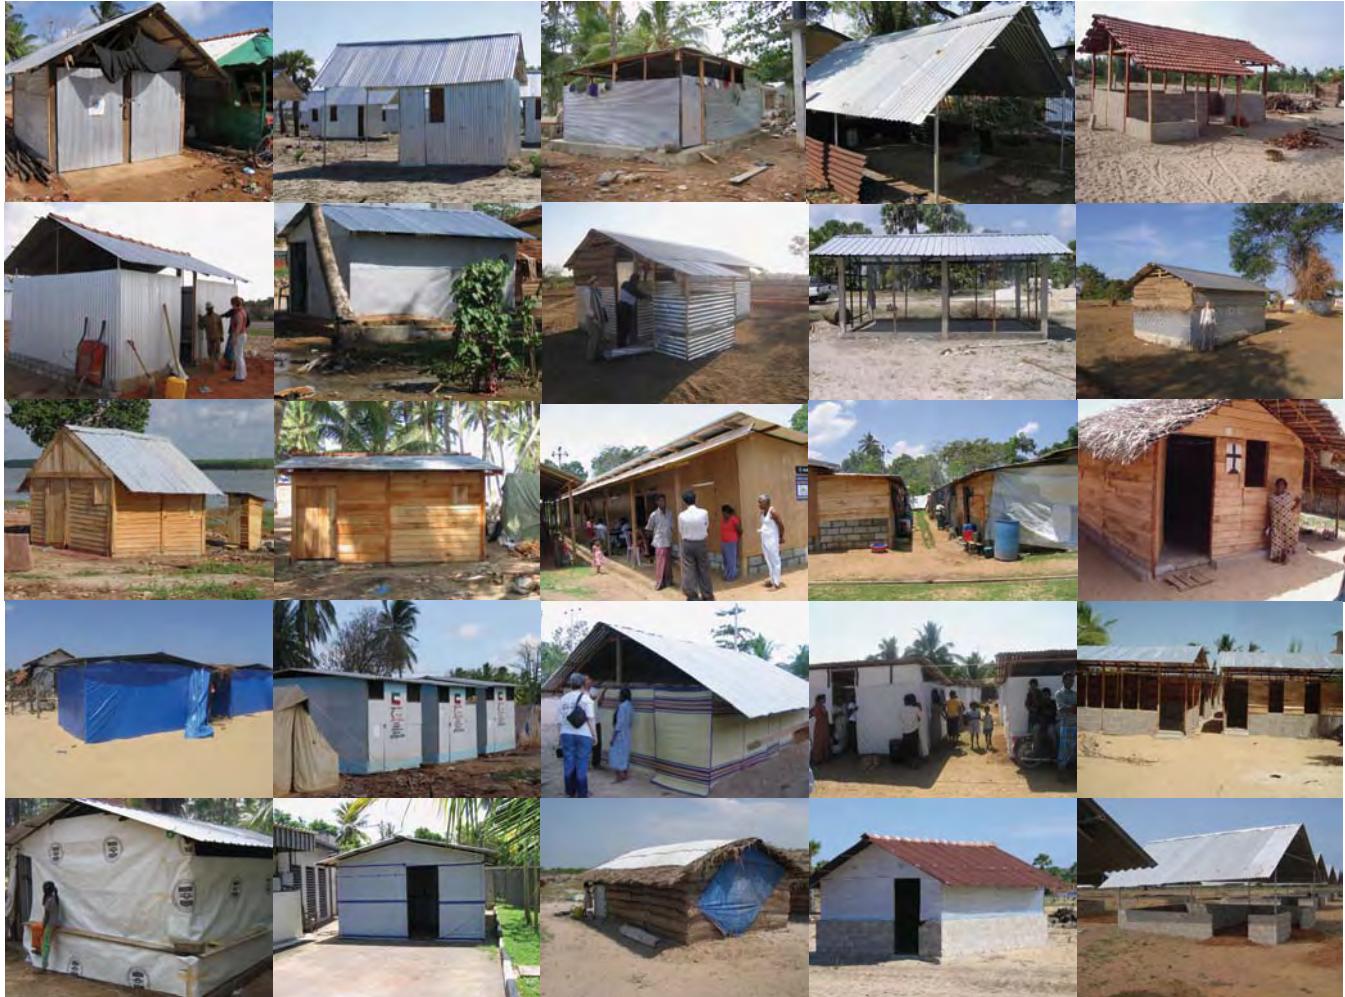
The shelter strategy allowed for many different shelter designs. Over 70,000 transitional shelters were built.

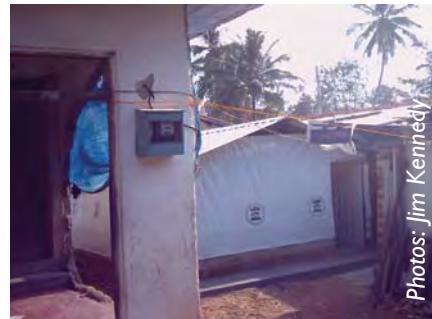
*Shelters were arranged in small groups on plots of land, often negotiated with the help of the NGO.*

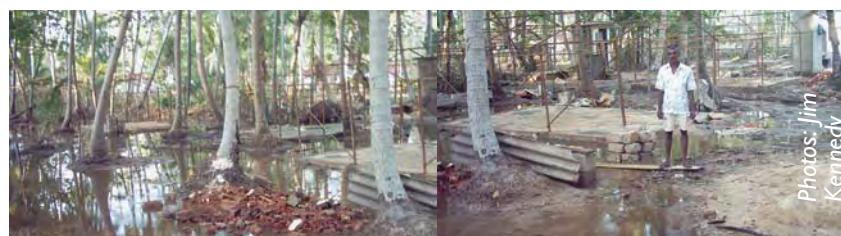
*Site with poor drainage. Not all available shelter sites were ideal.*

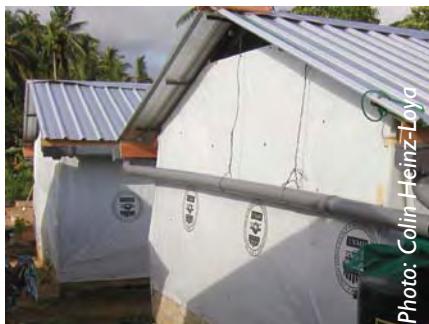
Shelters built with tanks for rainwater harvesting  
Photo: Colin Heinz-Lloyd

A detached veranda was later added as an upgrade. This could be positioned on any side of the basic shelter and could be used either as additional living space or as a kitchen area. Later, guttering and rainwater harvesters, as well as roofing insulation and basic electrical wiring, were added.

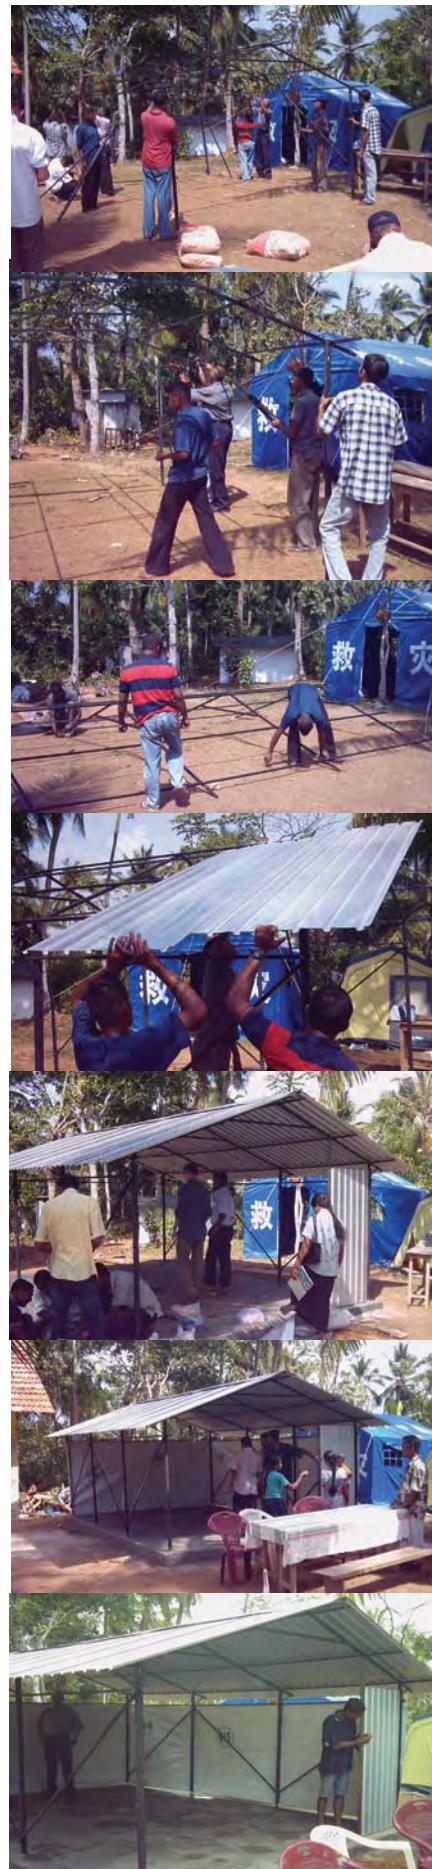
The construction of the shelters was not a difficult process.  
Photos: Jim Kennedy

The basic shelters were made from box-bar metal frames, which could be rapidly assembled into the basic skeleton of the shelter so that even those with little physical strength or prior construction knowledge could assemble them.

The metal frames also meant that the shelters could be relocated and reused if necessary, unlike shelters made from wood. The roofs were made from galvanised metal (a material specifically insisted upon by the beneficiaries to reflect their perceived social status), with open eaves under the roofs to provide for ventilation.

The beneficiaries were asked to provide the rubble for the raised foundation and the sand for the cement mix. A half-wall of concrete blocks was built along the edge of the foundation. Each household was given a small grant to do the masonry or to find local craftsmen. The sides of the shelters were then initially covered with plastic sheeting, which was reinforced by plywood. The work was done by 'shelter crews' of local tsunami-affected youth from the communities involved.
