## A.16 Somalia, Somaliland - 2009 - Conflict / drought

### Urban shelter upgrade

Somalia conflict.  
Displacement sites in Hargeisa.

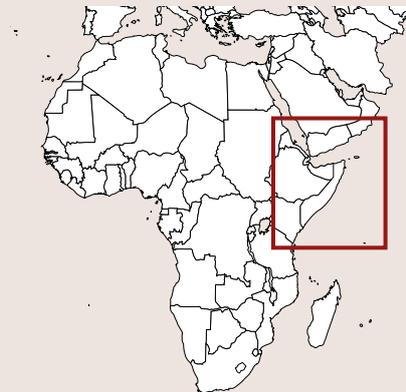
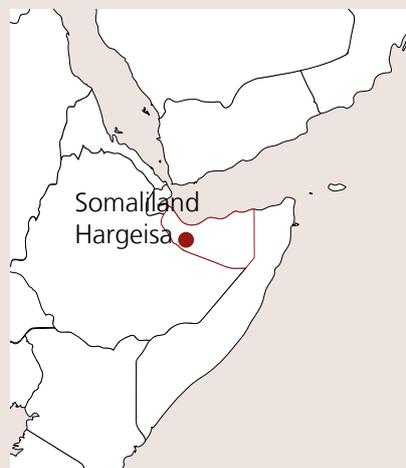
The shelters that were constructed had a timber frame made from imported timber, and a corrugated iron roof and walls. The shelters were based on shelters observed across Hargeisa, that had been built by low income families.

The shelters used simple post foundations so they can be easily dismantled and removed at any time, with all components easy to transport in case of relocation.

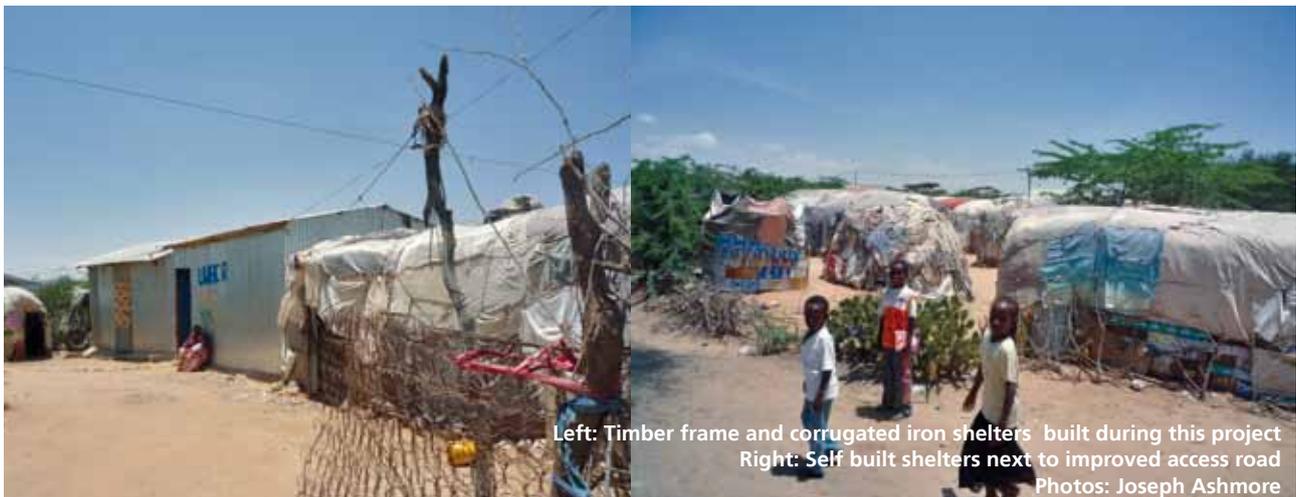
Left: Timber frame and corrugated iron shelters built during this project  
 Right: Self built shelters next to improved access road  
 Photos: Joseph Ashmore

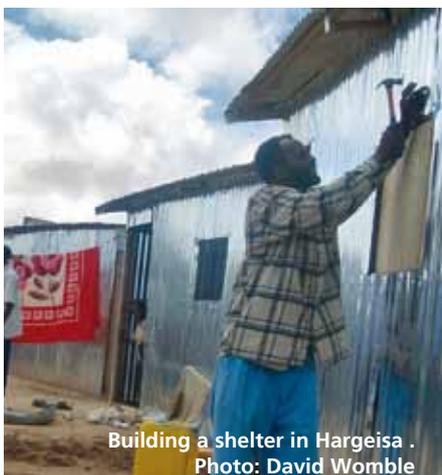
Building a shelter in Hargeisa .  
Photo: David Womble

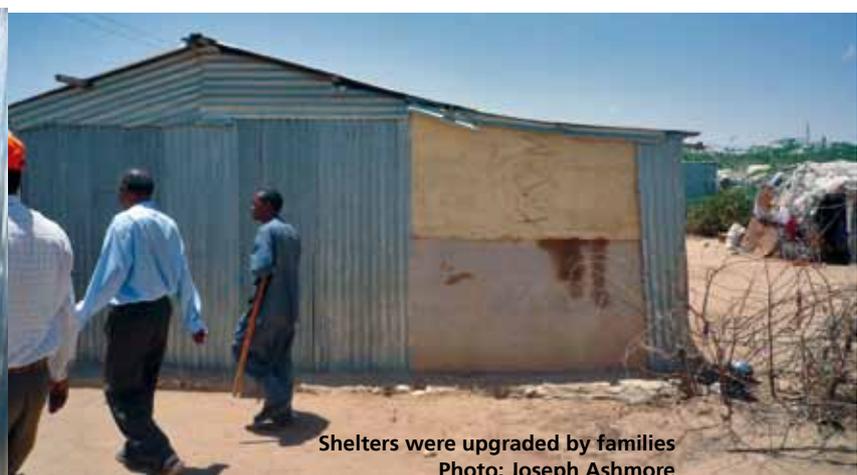
Shelters were upgraded by families  
Photo: Joseph Ashmore

Surprisingly, the structures were not excessively hot in comparison to the previous self-built shelters (Tukuls / buuls) in the camp. Dust was a greater concern to occupants than the temperature. Common upgrades made by families include

- plastic sheet for ceilings
- plastic sheeting, fabric and cardboard for walls
- plastic sheet or lino for flooring.

In some cases families have upgraded shelters by building enclosed extensions and improved flooring.
