## A.26 Philippines - 2010 - Typhoon Megi

### Case study:

Typhoon Megi

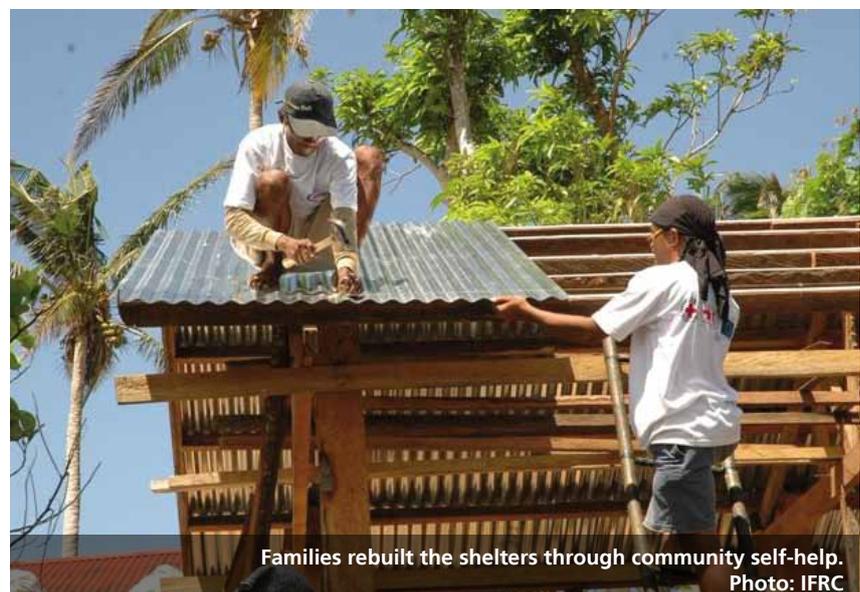
Families rebuilt the shelters through community self-help.

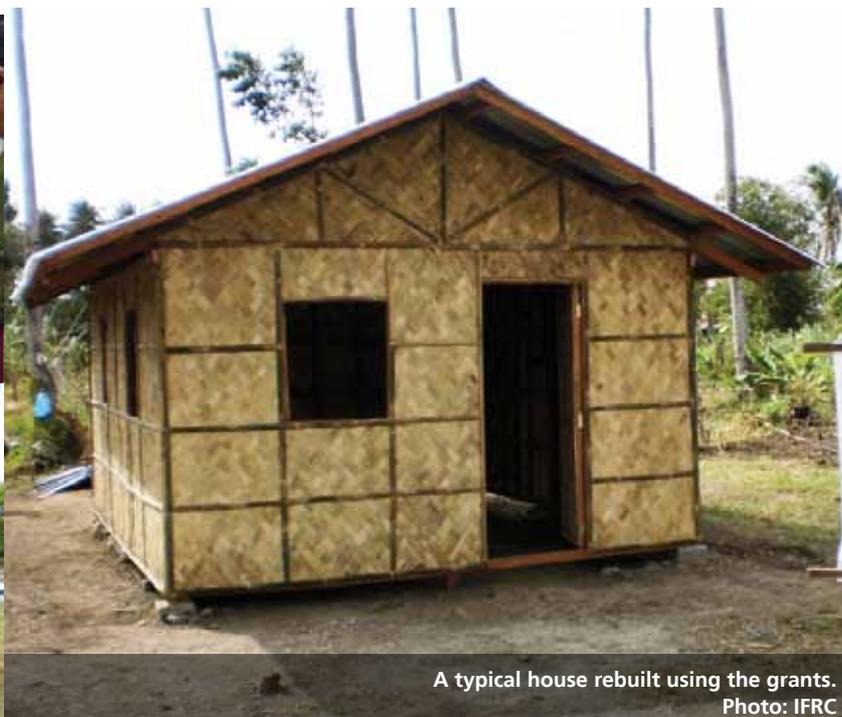
A typical house rebuilt using the grants.  
Photo: IFRC
