## A.16 Lebanon – 2007 – Conflict

Palestinian “gatherings” in and around Saida, southern Lebanon

Repairs of 557 shelters, including 412 roof repairs

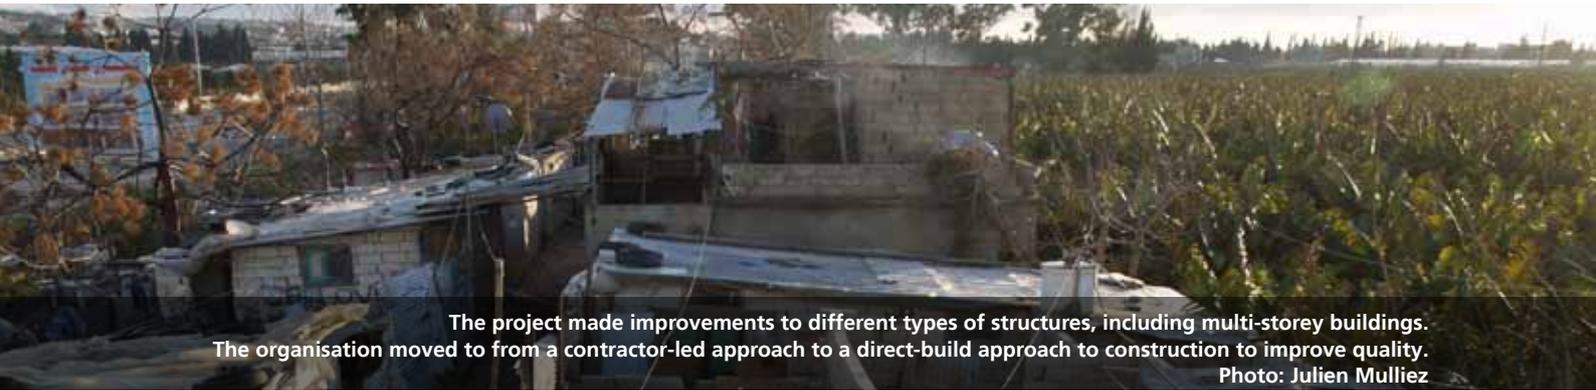
The project made improvements to different types of structures, including multi-storey buildings. The organisation moved from a contractor-led approach to a direct-build approach to construction to improve quality. Photo: Julien Mulliez

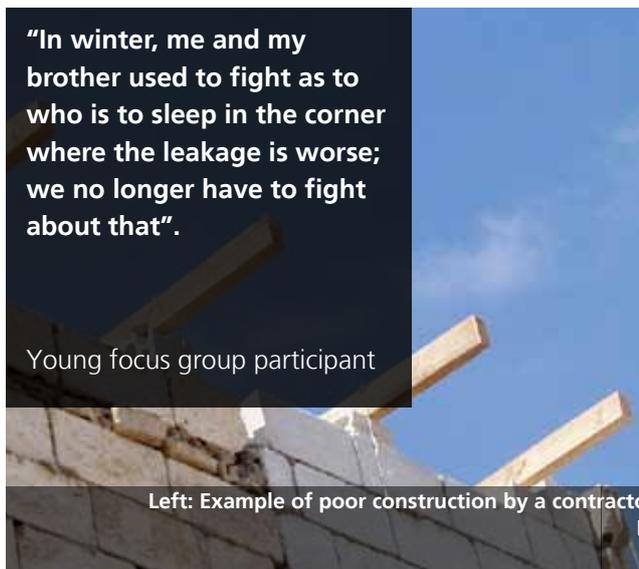
Left: Example of poor construction by a contractor in 2007, Wooden girders insufficient to support the new roof.

The organisation made a transition from contractor-led rehabilitation to direct-build. This decision was taken following concerns over the quality of contractor's work. Those contractors that were able or willing to work in the gatherings often used unskilled labour and amateur equipment.

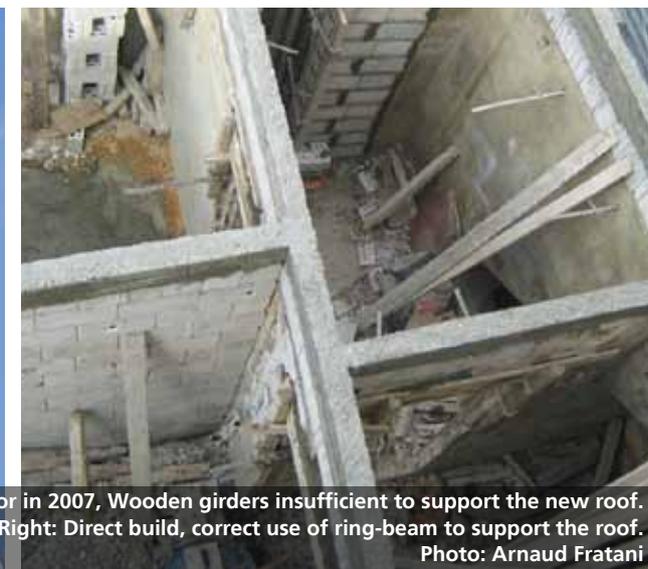
Right: Direct build, correct use of ring-beam to support the roof.

To support rehabilitated roofs, concrete ring beams were introduced. These would reinforce the structure, add a slope for the roofs and provide connections to support the roofing girders.

Steel reinforcement was used in the corners to connect walls together and make the structure more earthquake resistant.
