# SECTION A

## A.1 Afghanistan - 2009 - Conflict returnees

### Case study: Winterisation

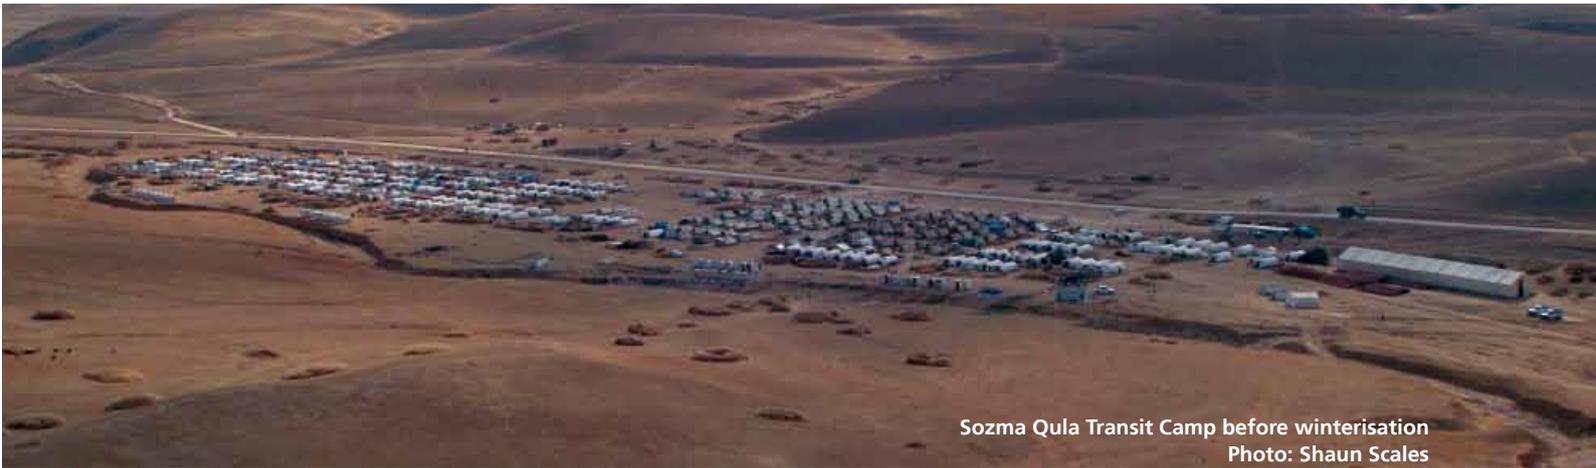
Sozma Qala Transit Camp before winterisation  
Photo: Shaun Scales

The original transit camp facilities were built to provide temporary support and were not intended for winter occupancy. Tents were provided as family shelters and a basic water delivery system had been developed.

Inadequacy of the tents had led to the population in the camp being extremely vulnerable to the coming severe winter weather. The largest element of the winterisation program was the provision of additional shelter to ensure that families living in tents had improved shelter.

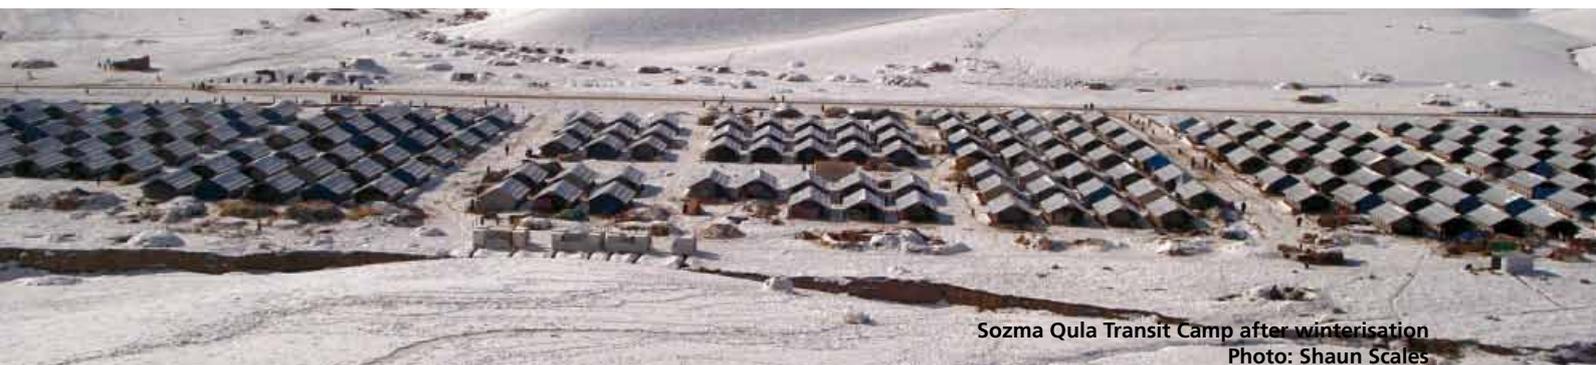
Sozma Qala Transit Camp after winterisation  
Photo: Shaun Scales

Bamboo structures clad in plastic sheeting were built around existing tents. Sections of the structures were prefabricated by local carpenters in a warehouse tent within the camp. They were then passed to beneficiary assembly teams for shelter construction on designated family plots.

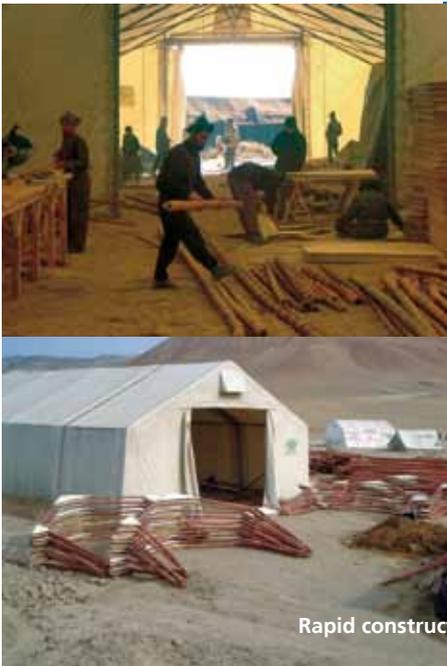
Rapid construction process - materials were prefabricated in a warehouse and assembled on site  
Photo Shaun Scales

The assistance delivery process was streamlined by having raw materials delivered directly to site and then processed through the warehouse tent.

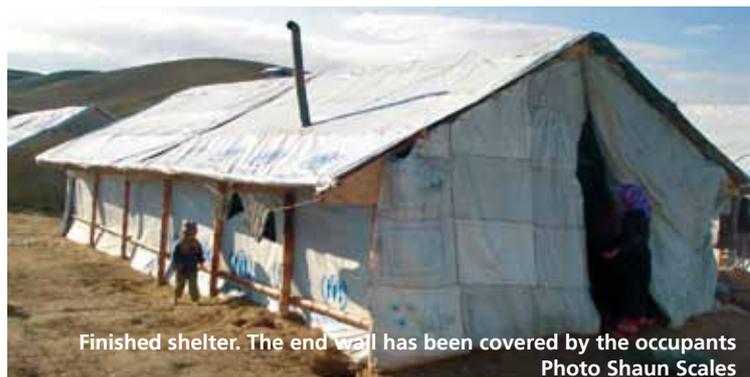
Finished shelter. The end wall has been covered by the occupants  
Photo Shaun Scales

The shelters were known as 'Weather Mitigating Tent Shelters' (WMTS) and were provided as a temporary shelter suitable for winter.

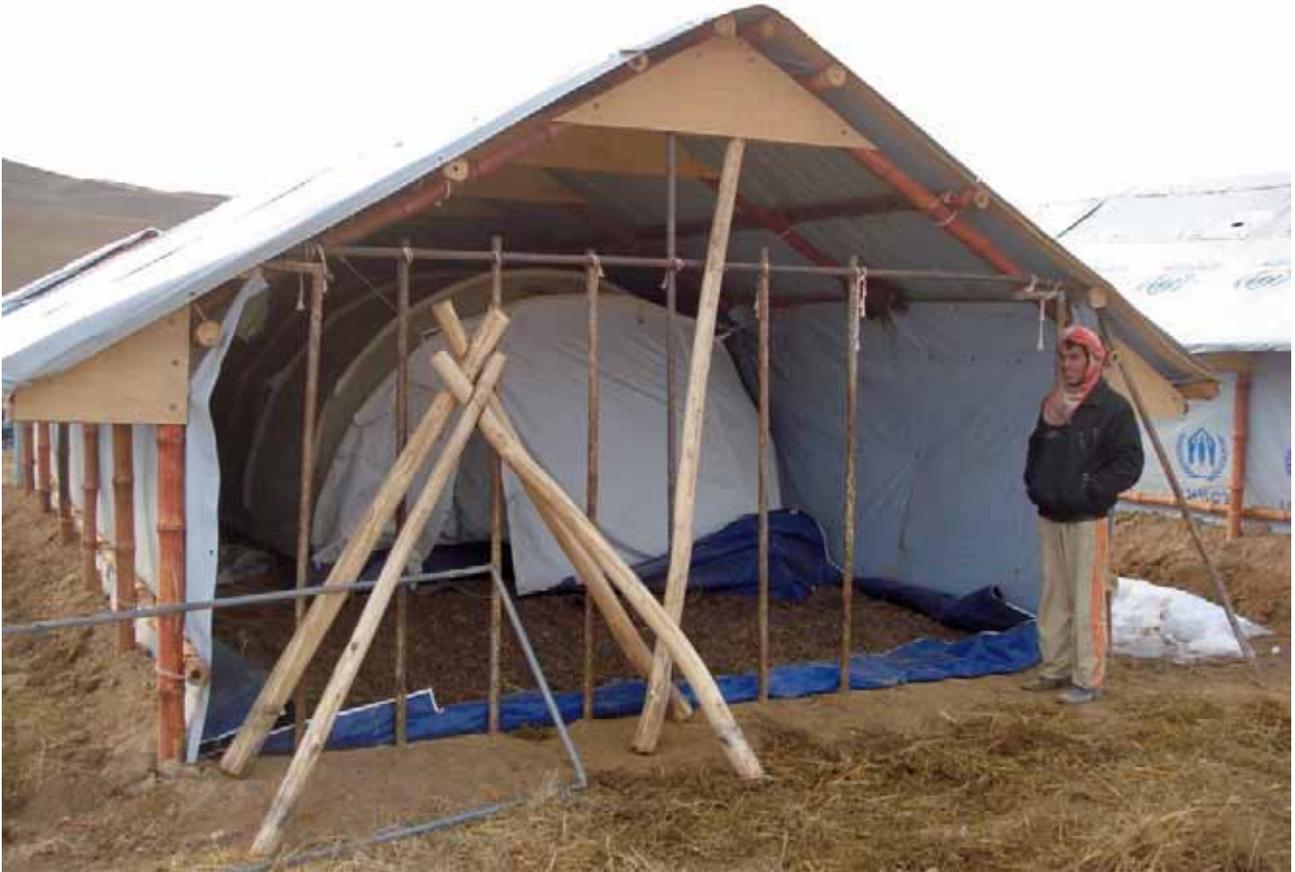
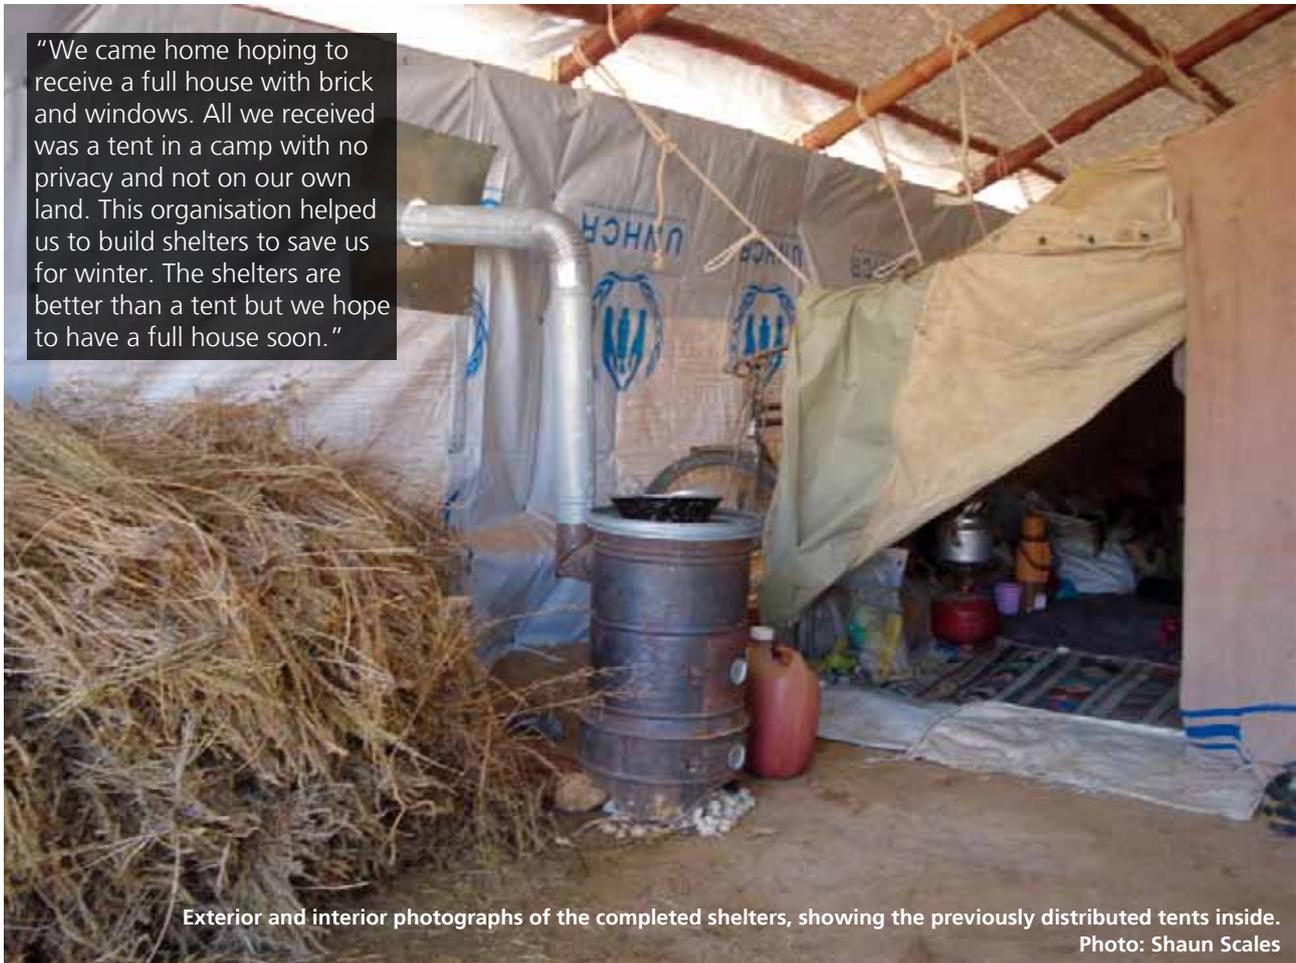
Exterior and interior photographs of the completed shelters, showing the previously distributed tents inside.
